McFarland Municipal Center Mechanical, Electrical, Plumbing, and Structural Conditions Assessment

The Village of McFarland
McFarland, WI

The McFarland Municipal Center is undergoing a process to repurpose the building for new use. The City of McFarland retained SEH to review the existing HVAC and plumbing equipment and provide an opinion on condition, life span, and operability. The results of this study will be used to determine how this equipment will be utilized, or when it will need replacement throughout the transitional period ahead. As part of this evaluation, SEH reviewed the existing equipment schedules, visited the site, and spoke with facility staff about maintenance and operability.

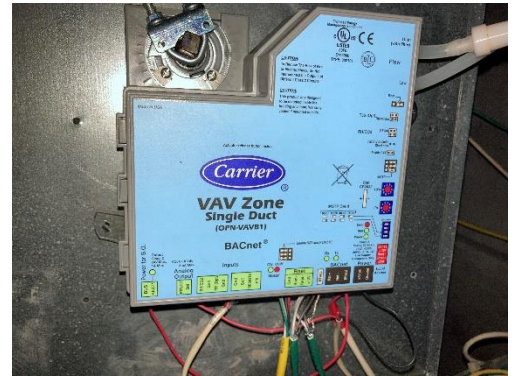
Figure 1: Carrier VAV Box Controller

- VAV Boxes are in fair, operational condition with visible corrosion on most. Staff has indicated that the hydronic system has created many problems and needs to be overhauled upon building reconfiguration. Staff indicated that control valves have failed at several places around the hydronic system, resulting in water damage, and times when the entire building was without heat.

- All VAV Boxes are in approximately the same condition.
- It is recommended that the VAV boxes are replaced upon reconfiguration of the building along with associated control valves, piping, and controls.

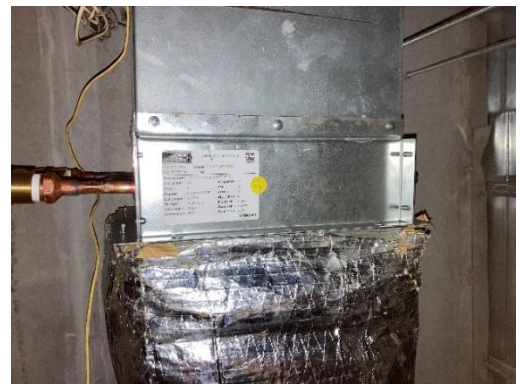
Figure 2: Hot Water Coil for VAV-4.02

- Staff indicated that water flow through the system is too fast, resulting in multiple worn out pipe elbows.
- Staff indicated that isolation valves need to be added to the hydronic system to perform repairs, as the current configuration requires shutting down the entire system to fix any failures.

- It is recommended that the hydronic system is rebalanced, and system pumps are replaced. (See section 2.5 Hydronic Pumps).

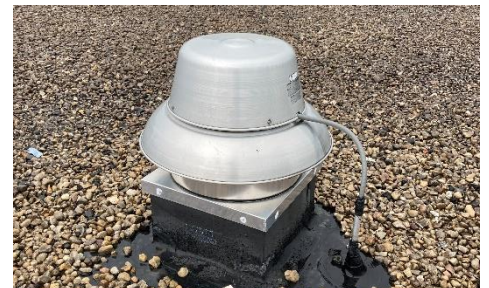
Figure 3: Jenco Downblast Exhaust Fan

- EF-1 appears in fair, operational condition with small amounts of visible corrosion. This fan is nearing the end of its serviceable lifetime. Manufacture date of the unit is not known. Continue regular maintenance as needed and expect replacement by 2025 or upon failure.

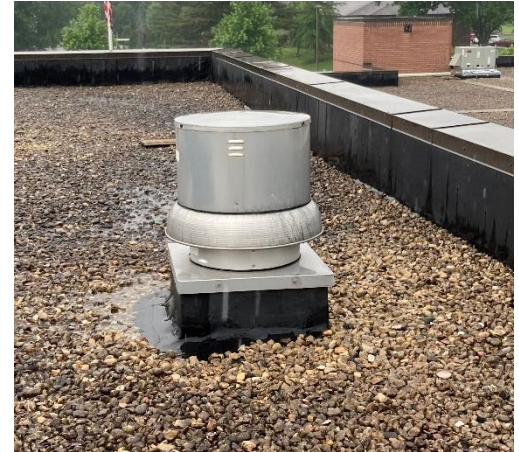
- EF-5 is no longer operational. Visible corrosion. This fan was originally designed to exhaust fumes from the fire garage but was replaced by the new tailpipe connected fume exhaust system. Demolish and replace if garage space is maintained as a garage through transition.

Figure 4: EF-5, visible corrosion. Carnes Downblast Exhaust Fan.

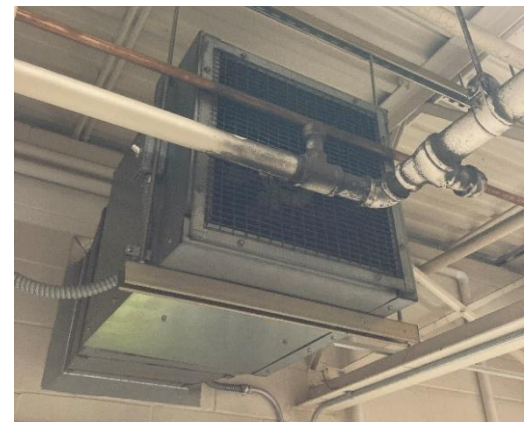
Figure 5: SF-1, Mechanical Mezzanine Wall Mount Ventilator

- SF-1 appears in fair, operational condition with no amount of visible corrosion. This fan is nearing the end of its serviceable lifetime. Manufacture date of the unit is not known. Continue regular maintenance as needed and expect replacement by 2025 or upon failure.

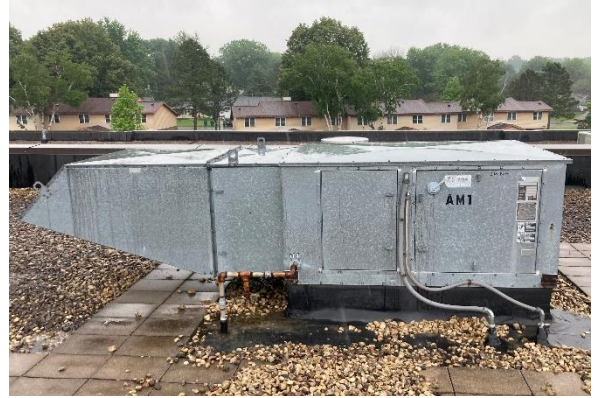
Figure 5: MAU-1, Fire Garage Make Up Air Unit.

- MAU-1 is original to the building and is past its serviceable lifetime with visible signs of corrosion. This unit should be demolished and replaced if the fire department garage remains a garage through transition. If the space is converted to a different use, ventilation, heat, and cooling requirements will change.

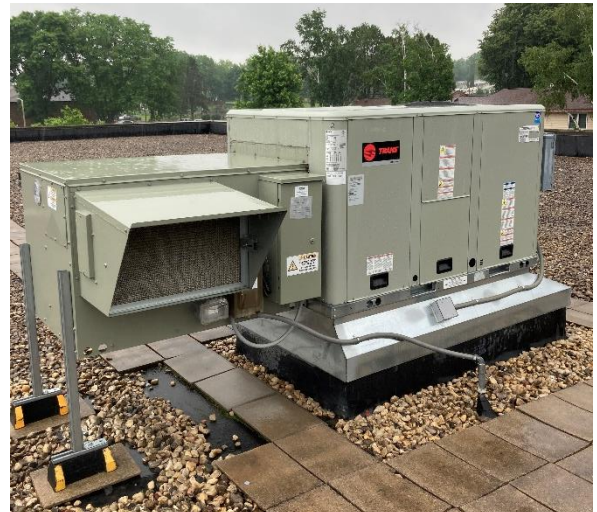
Figure 6: RTU-2, Trane Rooftop Air Handling Unit.

- RTU-2 is operational and in excellent condition with no signs of corrosion. This unit was manufactured in 2020. Continue regular maintenance and expect replacement of this unit between 2035-2040.

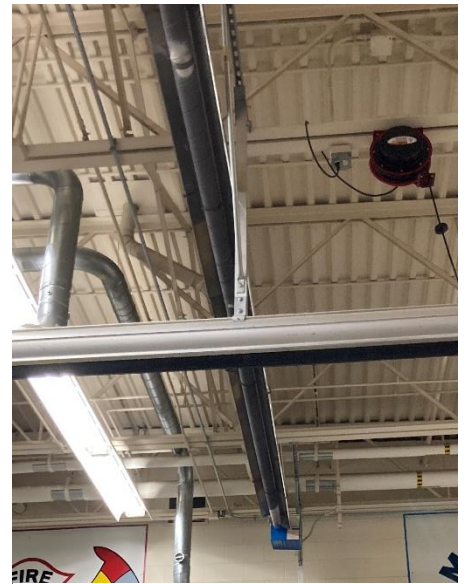
Figure 7: Gas Fired Radiant Heater

- GRH-1 appears to be in fair, operational condition with slight corrosion visible on the heating element. This unit is nearing the end of its serviceable lifetime and should be demolished and removed upon transition of the building. The need for replacement will be determined by use of the space.
- GRH-2 appears to be in fair, operational condition with slight corrosion visible on the heating element. This unit is nearing the end of its serviceable lifetime and should be demolished and removed upon transition of the building. The need for replacement will be determined by use of the space.

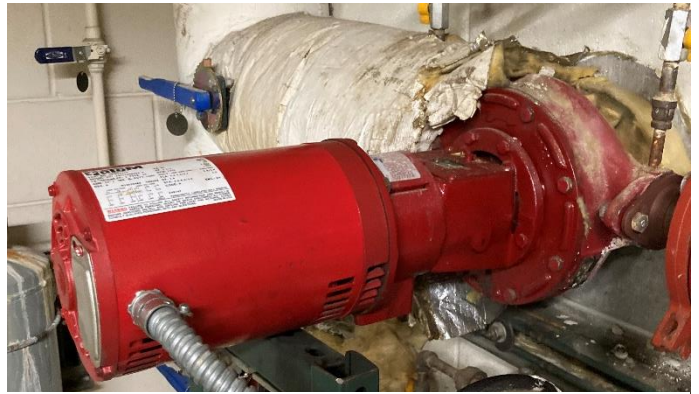
Figure 8: Pump P-1, Bell and Gossett Hydronic System Circulation Pump

- As staff at the facility has mentioned a large quantity of leaking valves, pipes, and worn-out elbows in the hydronic system, these pumps should be rebalanced as soon as possible to slow the flow of water within the system to 4-6 ft/s.

- As the pumps do not appear to be labeled and they are identical, pump P-1 will be designated as the pump installed above P-2. P-1 appears in fair, operational condition and original to the facility. In 2019 this pump received a replacement motor and bearing assembly. Continue regular maintenance and replace components as needed. Expect pump body replacement by 2040.

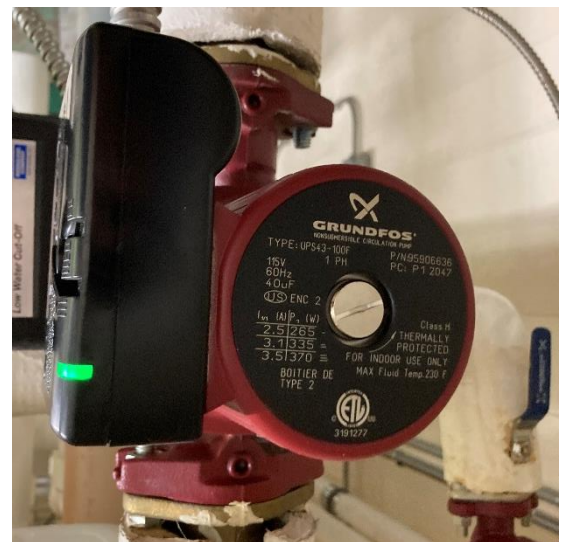
Figure 9: Grundfos Inline Three Speed Boiler Pump

- Pump P-3 was replaced in 2010 and appears in excellent condition with no visible corrosion. Continue regular maintenance and expect replacement by 2030.

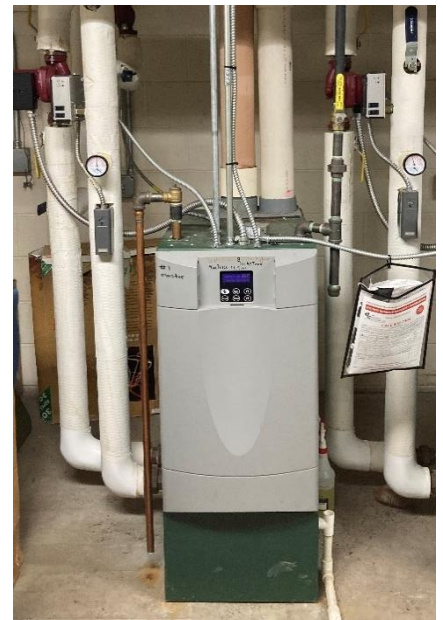
Figure 10: Peerless Boiler B-1

- Boiler B-1 appears to be in fair condition, operational, and with no visible corrosion. From conversations with building operators, no large issues have arisen from this boiler aside from regular maintenance.
- Boiler B-2 appears to be in fair condition, operational, and with no visible corrosion. From conversations with building operators, no large issues have arisen from this boiler aside from regular maintenance.
- Boiler B-3 appears to be in fair condition, operational, and with no visible corrosion. From conversations with building operators, no large issues have arisen from this boiler aside from regular maintenance.

- A typical boiler lifetime is 15-20 years under good maintenance. Boilers 1-3 will need replacement between 2026 and 2031 or as they fail. Continue regular maintenance for the remainder of their lifetime.
- Upon boiler replacement, ensure heating capacity matches what is appropriate for the space. Provide new controls, pumps, and associated piping.

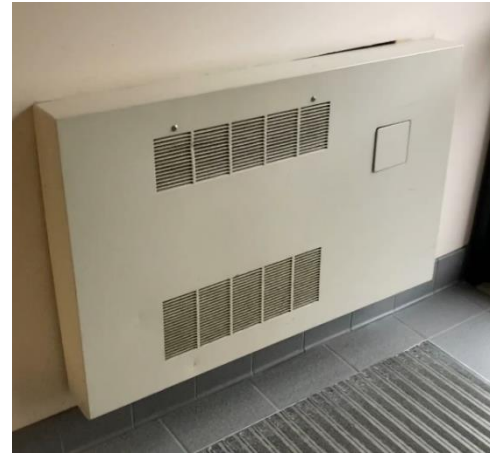
Figure 11: CUH-4, Hydronic Cabinet Heater

- All cabinet unit heaters are in the same approximate condition and are original to the building. All are in operational condition but nearing the end of their serviceable lifetime. Replace upon failure or by 2027.

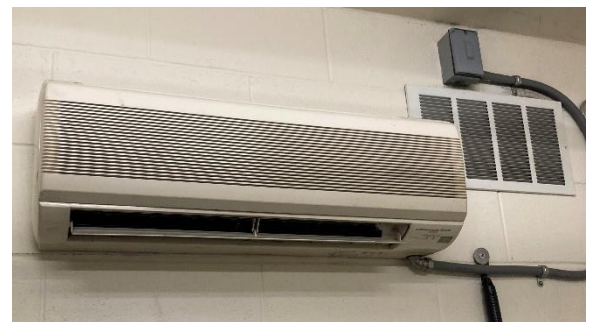
Figure 12: Mitsubishi Split System Heat Pump

- HPU-1 and HPU-2 are in fair, operational condition. As these heat pumps appear original to the building, they are nearing the end of their serviceable lifetime. Expect replacement between 2025-2030.

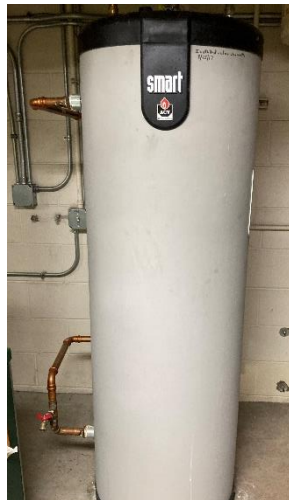
Figure 14: GWH-3, Operational Water Heater

- GWH-3 appears to be in excellent condition and was installed in 2017. Continue regular maintenance and expect replacement from 2032 to 2037.
- Staff did not mention any issues arising from only having a single water heater; one could be added for redundancy to help with repairs and demand.

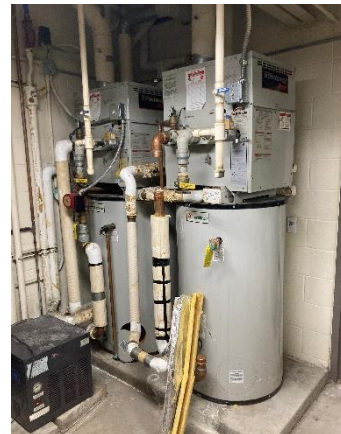
Figure 13: GWH-1,2 Decommissioned Water Heaters

- GWH-1 appears to be original to construction of the building. It appears to be in poor condition and not currently operational. Valves were closed on associated piping, and the power switch was in the off position. Demolish and remove all associated piping and valves.

- GWH-2 appears to be original to construction of the building. It appears to be in poor condition and not currently operational. Entire sections of pipe have been removed. Valves were closed on associated piping, and the power switch was in the off position. Demolish and remove all associated piping and valves.

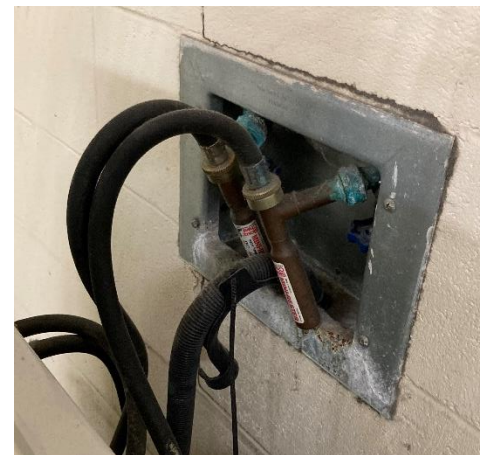
Figure 15: Visible Corrosion Example, Washer Box

- Staff did not indicate any large number of issues stemming from the domestic water piping or fixtures.
- Corrosion is visible on many fixture connections to the water system. This piping should be demolished and replaced as it is reaching the end of its serviceable lifetime.
- Most fixtures were installed in 1999 upon construction of the building. Due to this, all fixtures should be demolished and replaced by 2027, upon failure, or when the Municipal Center undergoes renovations for conversion to a new usage.
- 2" CW hose bib connections currently exist within the fire department garage to fill tanker trucks. If this space is converted to something else without the need for large amounts of water, these connections should be demolished back to the main and capped.

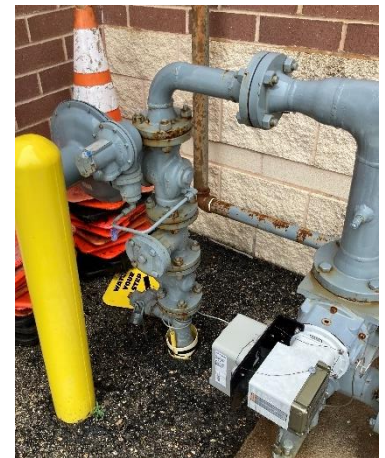
Figure 16: Rusting Gas Meter

- The gas meter is showing signs of rusting. This meter is owned by the local utility and replacement should be handled through them when replacement is determined to be necessary.
- Regulators for individual equipment connections should be replaced when connected equipment is replaced. These regulators handle supply pressures of 5 PSIG and reduce to the correct supply pressure for each piece of equipment.

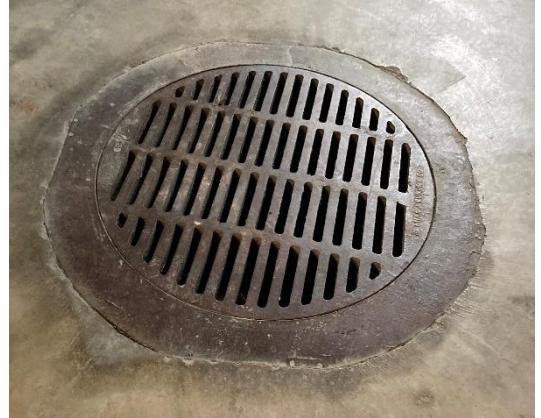
Figure 17: Garage Catch Basin

- Sanitary fixtures appear in good condition with no noticeable amounts of corrosion. Replace fixtures as needed or once corrosion is noticeable.
- Staff did not indicate any issues with sanitary sewer systems.
- Underfloor piping could not be analyzed.

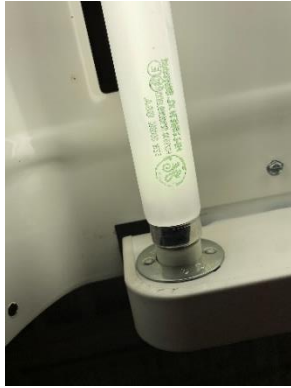
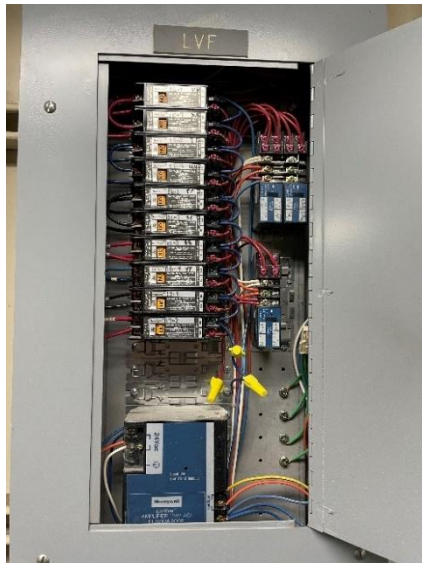
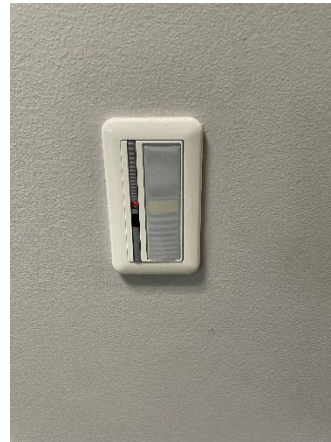
The fixtures and lighting controls tend to be in fair condition.

All existing light fixtures are recommended to be replaced within the next 5 years, or during the renovation of the existing building.

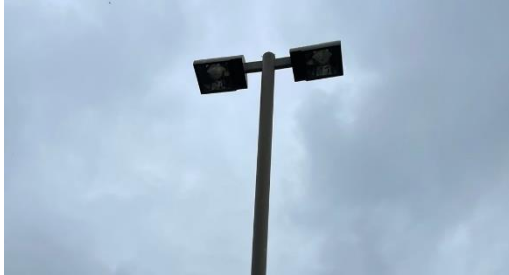
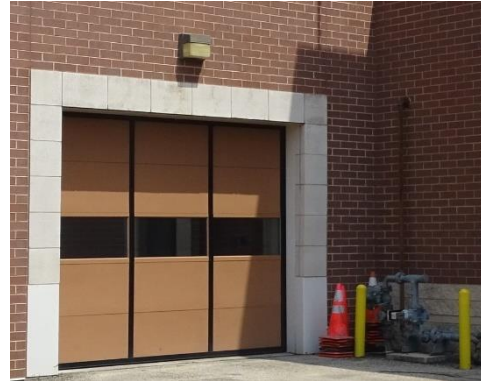
The fixtures tend to be in fair condition.

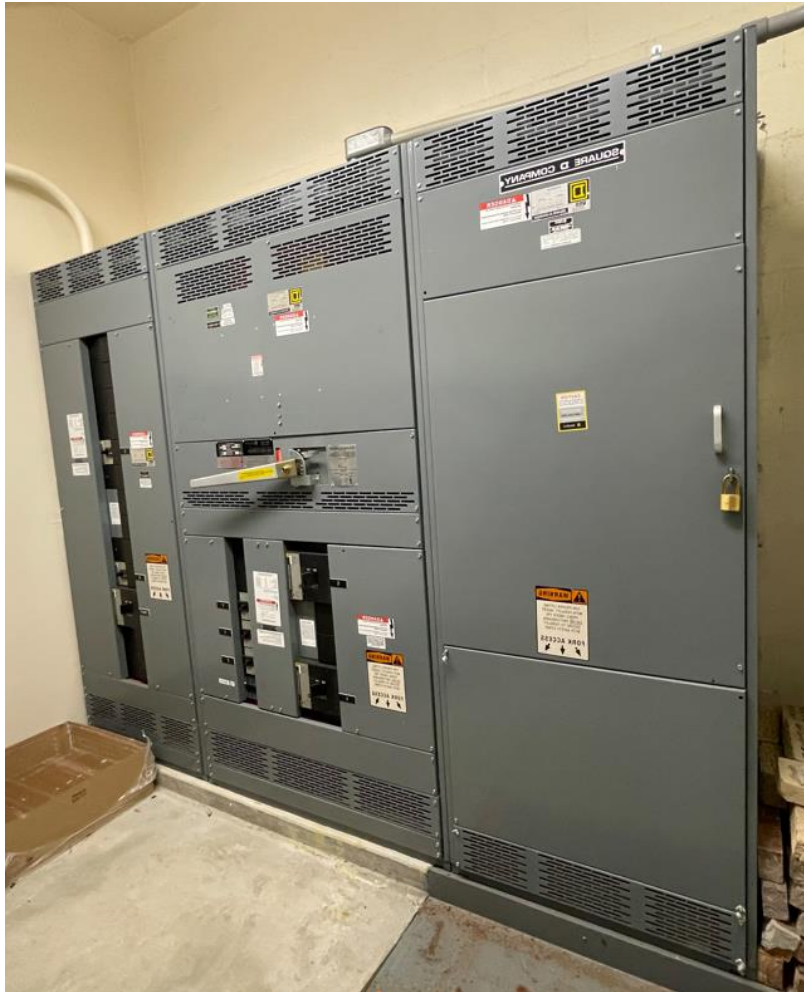
Figure 23: Existing Service Entrance Equipment

The service entrance equipment tends to be in fair-to-good condition.

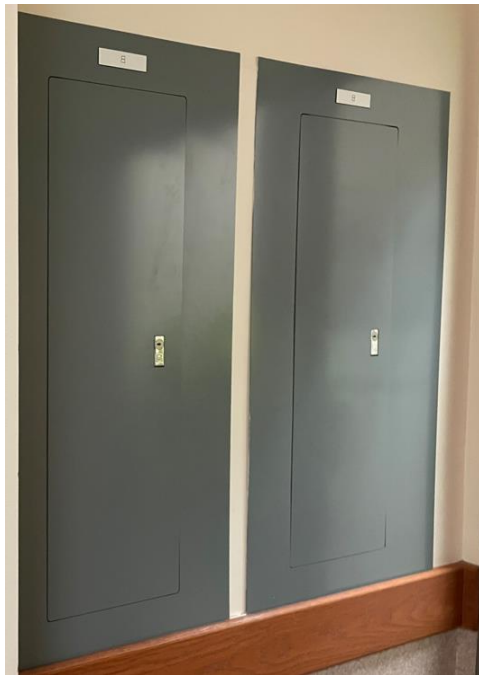
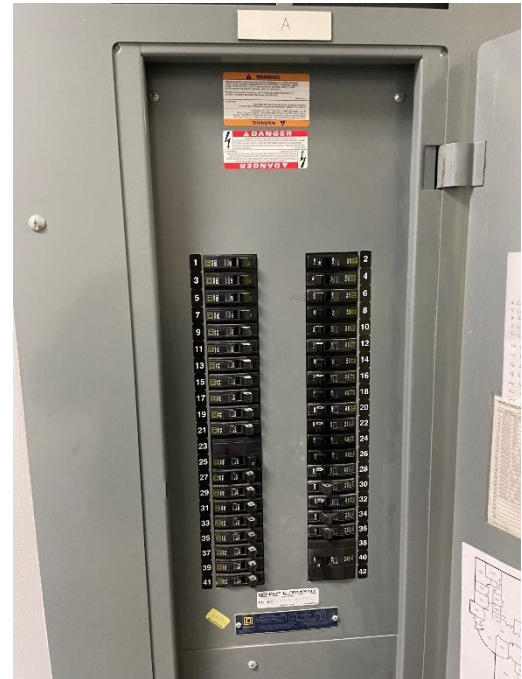
The panelboards tend to be in fair-to-good condition.

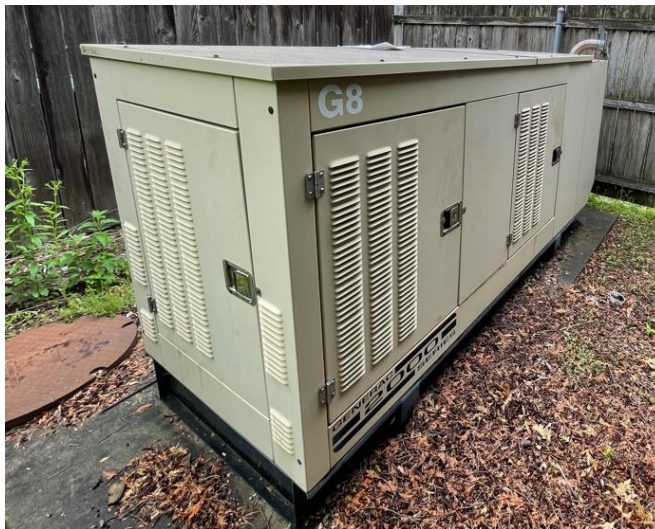
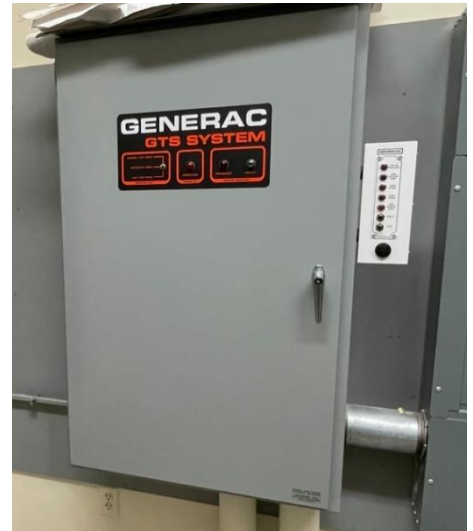
The backup generation genset and ATS at or near the end of its service life. EMDP is in similar condition as the power distribution equipment and has 15-20 years of service life remaining.
