- a. Discussion and action regarding proposed Change Order #15 for the Public Safety Center project regarding to extend the final completion date for the repairs on the sinkhole.
- b. Discussion regarding revisions to the Village's Mission and Vision Statements.
- c. Discussion regarding 2023-2024 McFarland Strategic Implementation Plan as the Village Board goals and objectives for the coming year.
  - 1) Goal A: McFarland Municipal Center Campus
  - 2) Goal B: Public Infrastructure
  - 3) Goal C: Housing and Economic Development
  - 4) Goal D: Village Government

**AGENDA ITEM:** Discussion and action regarding proposed Change Order #15 for the Public Safety Center project regarding to extend the final completion date for the repairs on the sinkhole.

#### Subsurface Conditions

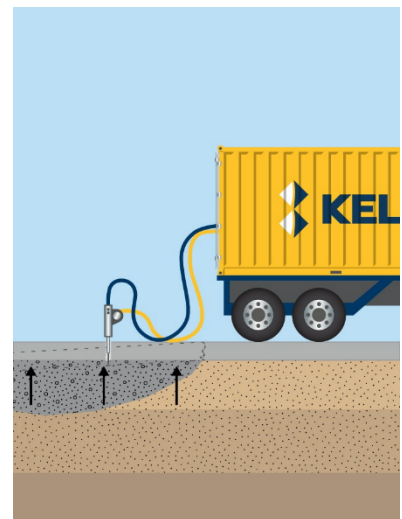
Keller uses a grout proportioner with cell phone monitoring available, which allows for the grouting operation to be monitored both at the trailer and at the point of injection via a cell phone app. This also provides the operator the ability to adjust the parameters (such as mix type, flow rate, pressure, and volume limits) in real time, while simultaneously monitoring for any movements or deflection of the ground or nearby structures. The use of this advanced monitoring and control system increases accuracy, efficiency, and quality control of the grouting while reducing risk. During grouting, Keller will use zip levels and/or laser levels to monitor slab movement during the

grouting operation.
